Coast Mountain Resources (2020)
19050 94 Avenue
Surrey, BC.
V4N4X8

July 25, 2022
File: 18403

**Re: Geological Investigation Report: Proposed Commercial Development
1451 Trowsse Road, Mill Bay, BC**

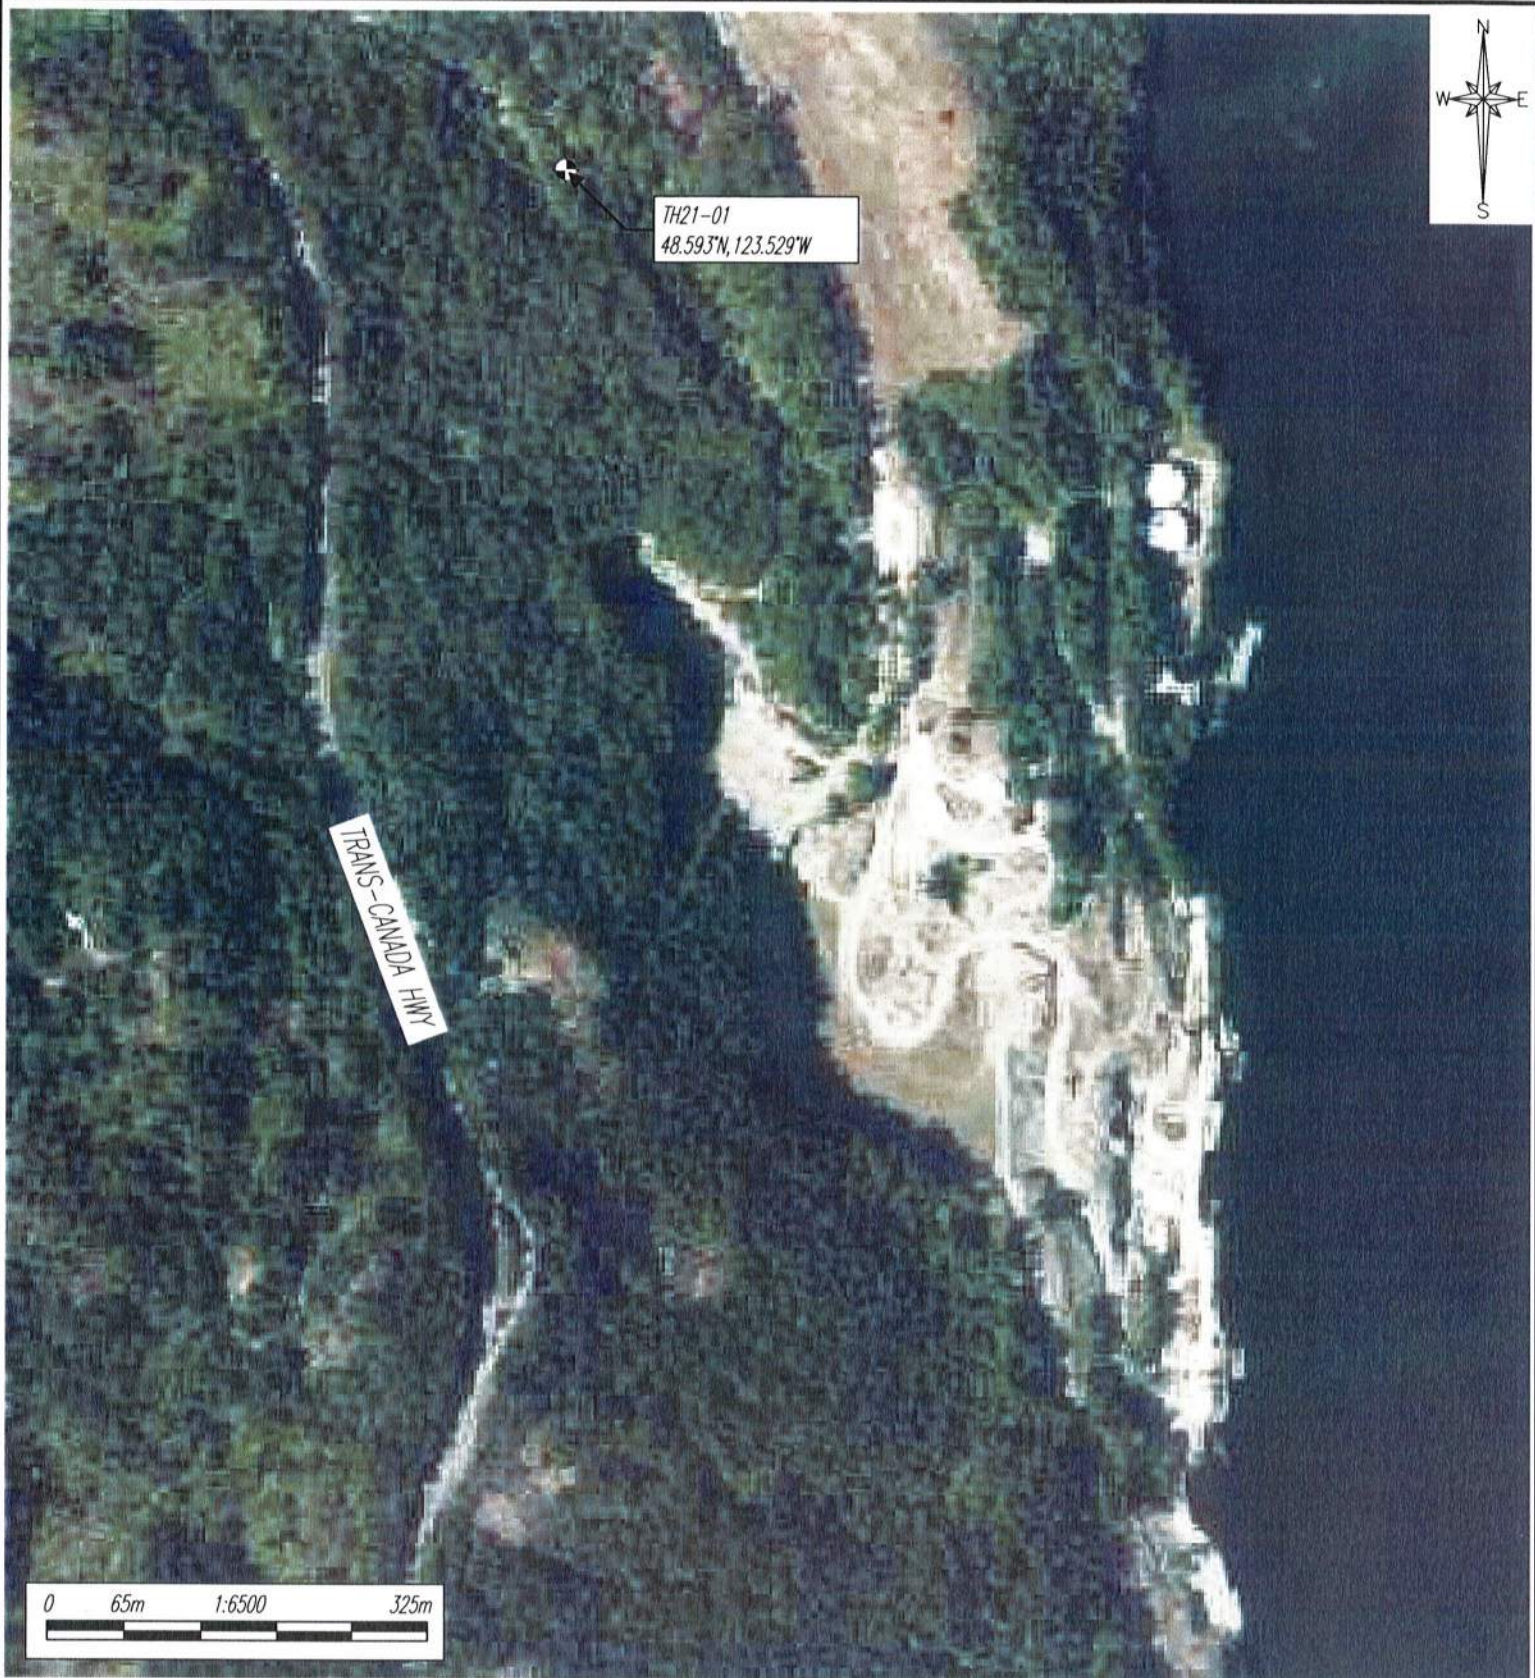
SITE PLAN

↖ [TH21-XX] - TEST HOLE (TH) LOCATION

The site is bounded by the Saanich Inlet to the east, Bamberton Provincial Park to the north, Highway 1 to the west and undeveloped forest to the south. The approximate elevation of TH21-01 is estimated to be approximately 150 m geodetic, based on elevations provided in Google Earth Pro.

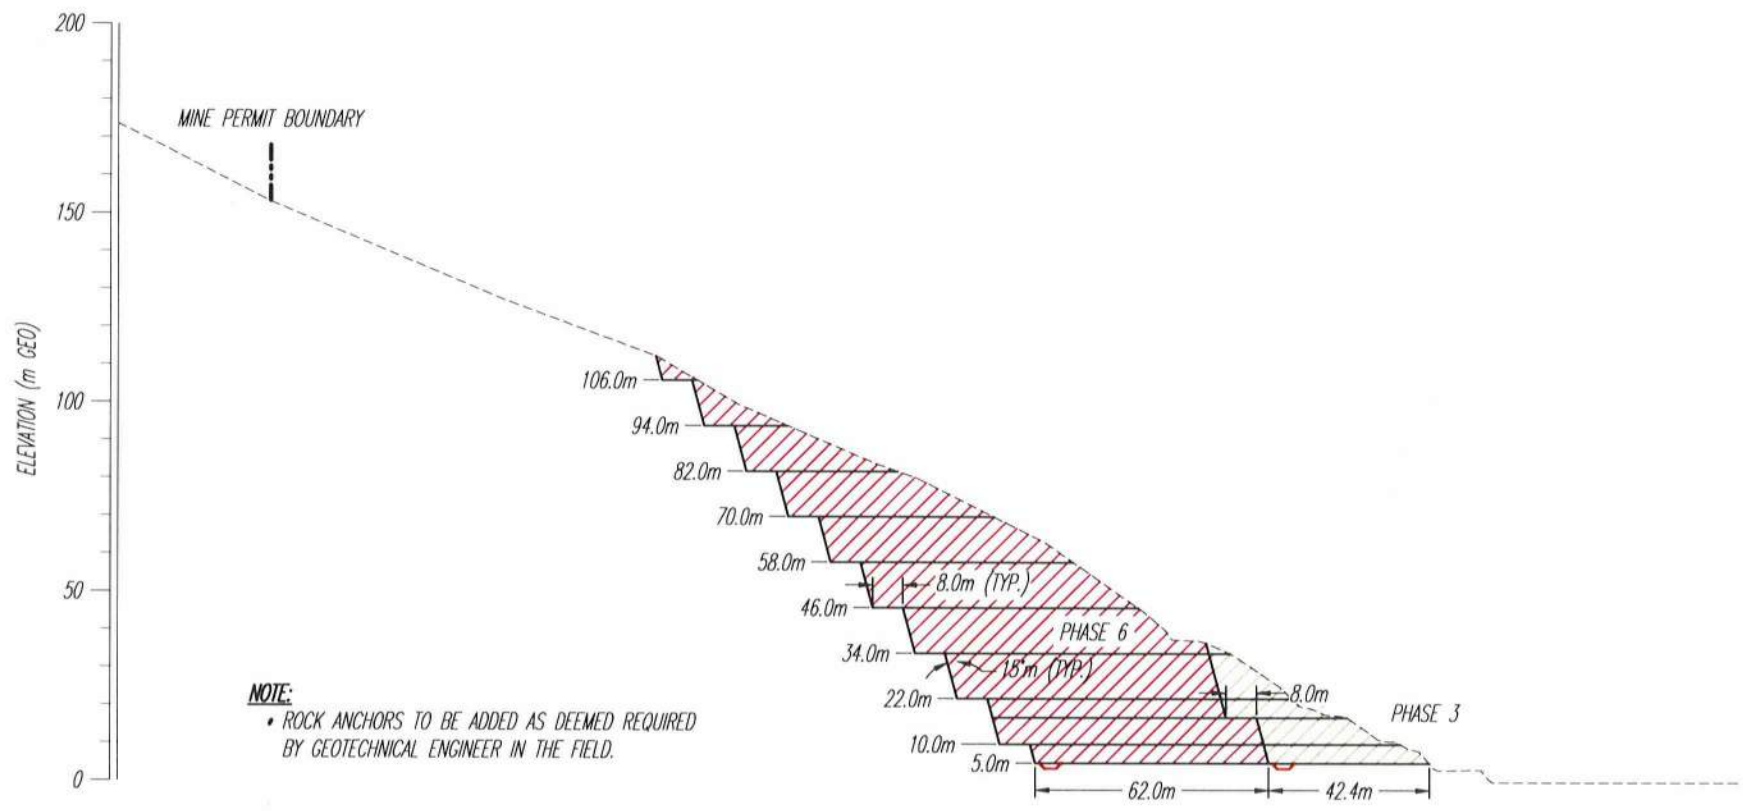
SECTION C
 1:2000

NOTE:
 • ROCK ANCHORS TO BE ADDED AS DEEMED REQUIRED BY GEOTECHNICAL ENGINEER IN THE FIELD.

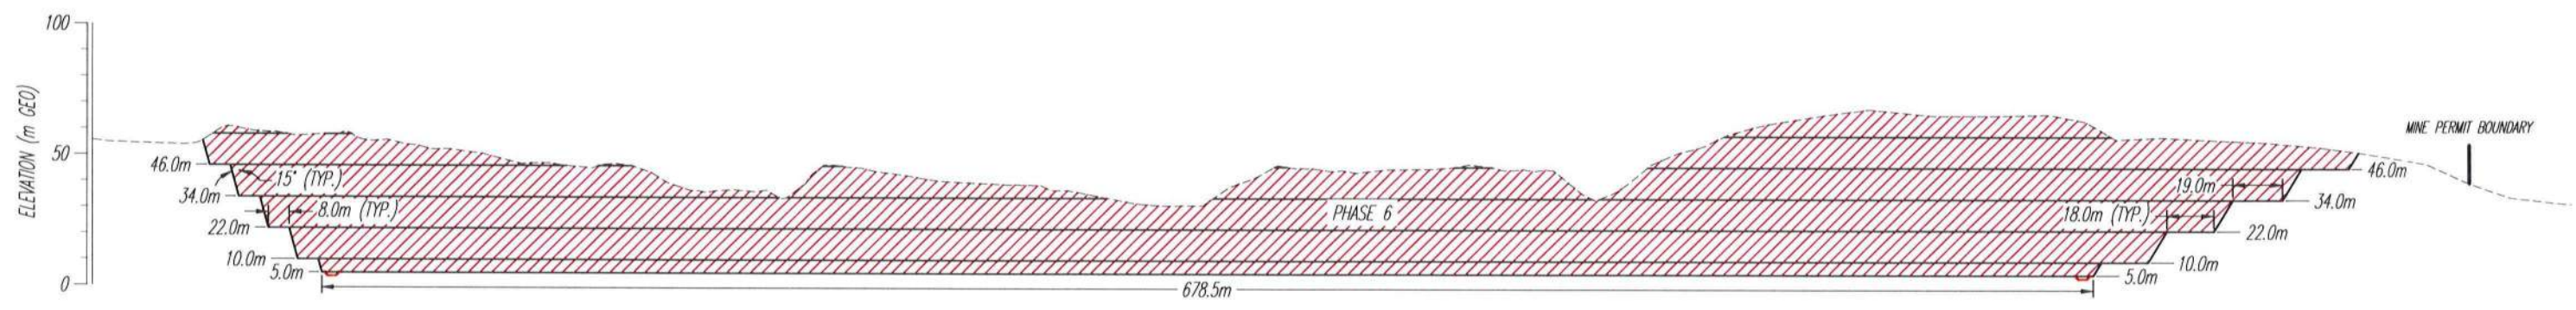
SECTION D
 1:2500

NOTE:
 • ROCK ANCHORS TO BE ADDED AS DEEMED REQUIRED BY GEOTECHNICAL ENGINEER IN THE FIELD.
